**Flood Control Project Maintenance
Levee Inspections**

Fall 2013 Levee Maintenance Deficiency Summary Report

Reclamation District No. 2107 Mossdale Island

Levee Inspection Report By Mile - Fall 2013

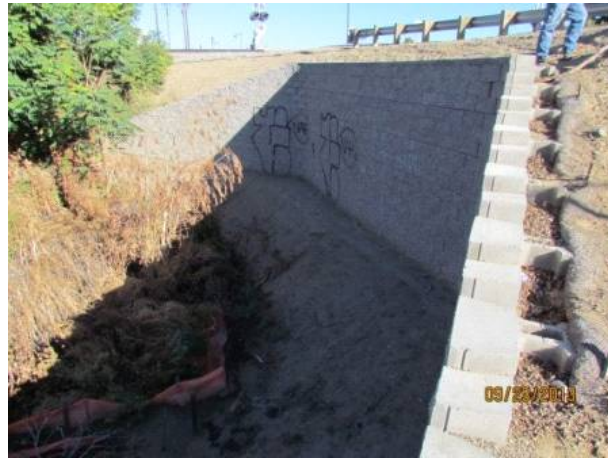
Levee Mile Report Line	4
Start Levee Mile	0.00
End Levee Mile	0.00
Location	Land Side
Category	Earthen Levee
Item	Encroachments

View of the retaining wall at the landside levee slope.

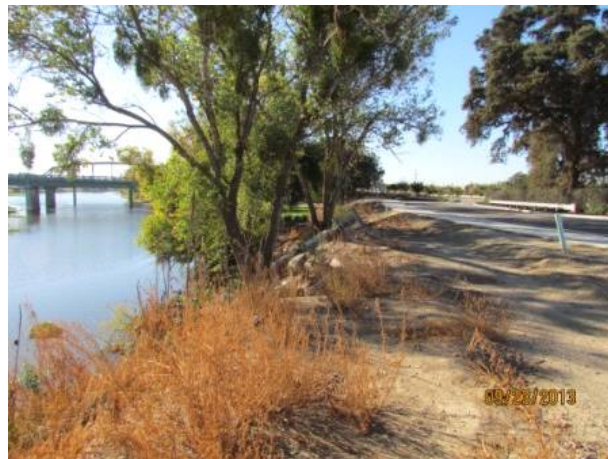
Levee Mile Report Line	5
Start Levee Mile	0.03
End Levee Mile	0.03
Location	Water Side
Category	Earthen Levee
Item	Trim / Thin Trees

Photo of waterside slope. Stumps present from prior tree removal for access and visibility.

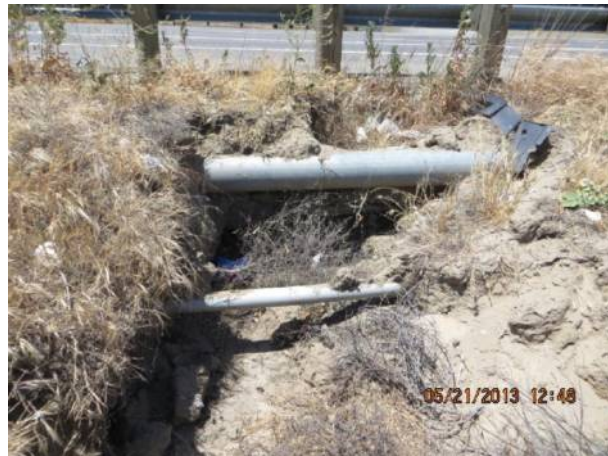
Levee Mile Report Line	8
Start Levee Mile	0.23
End Levee Mile	0.23
Location	Water Side
Category	Supplemental
Item	DWR UCIP Field Study

Pipes visible on LS next to roadway.

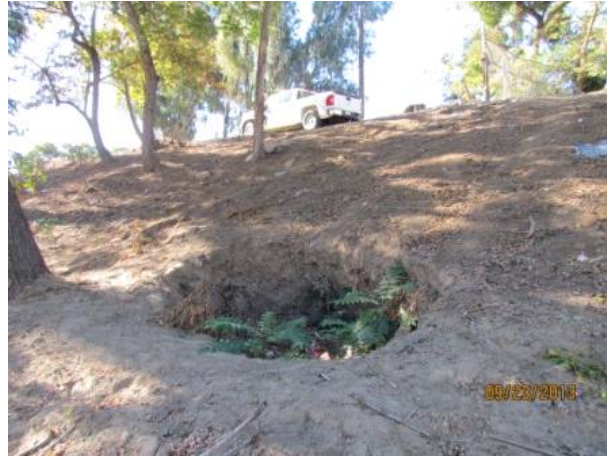
Levee Mile Report Line	13
Start Levee Mile	0.25
End Levee Mile	0.25
Location	Water Side
Category	Earthen Levee
Item	Encroachments

View of the ditch at the waterside levee toe.

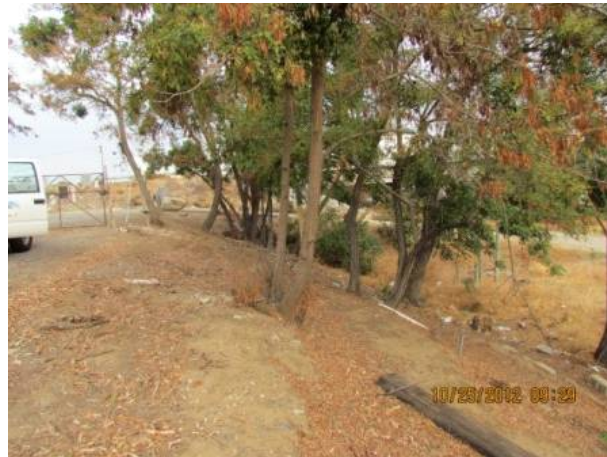
Levee Mile Report Line	14
Start Levee Mile	0.25
End Levee Mile	0.25
Location	Water Side
Category	Earthen Levee
Item	Trim / Thin Trees

DWR ID: DWR_RD2107_01_f_2013_76										
14	0.25	0.25	Earthen Levee	Trim / Thin Trees	WS	N Ma	T5 : Tree stumps.	37.784316 ° -121.306498 °	37.784316 ° -121.306498 °	2 Y
DWR ID: DWR_RD2107_01_s_2012_2

Tree stumps present on slope. They were left from prior vegetation removal for access and visibility.

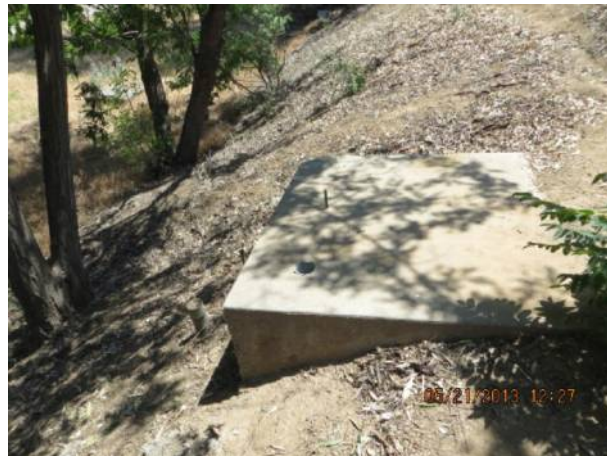
Levee Mile Report Line	16
Start Levee Mile	0.27
End Levee Mile	0.27
Location	Water Side
Category	Supplemental
Item	DWR UCIP Field Study

5X5 concrete pad with exposed electrical conduit on WS shoulder.

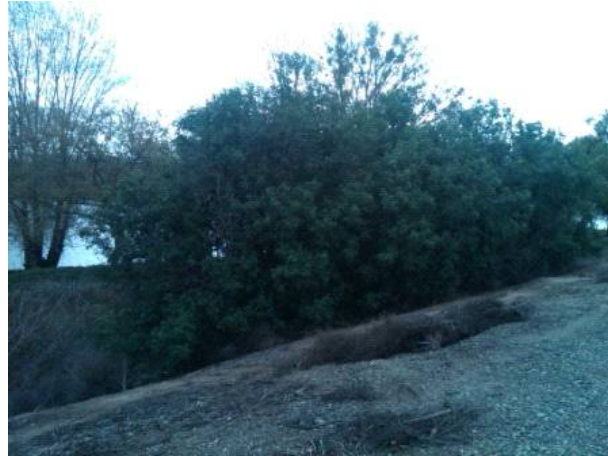
Levee Mile Report Line	18
Start Levee Mile	0.42
End Levee Mile	0.42
Location	Water Side
Category	Earthen Levee
Item	Vegetation
03/26/2012 Large elderberry located on water side slope.	
mkhashch_f_20130923_565.jpg

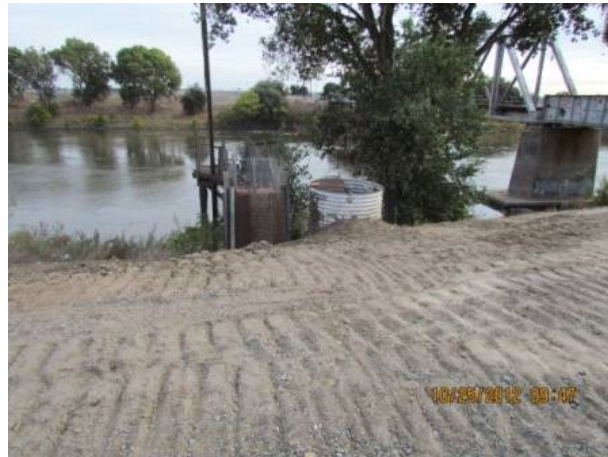
Levee Mile Report Line	19
Start Levee Mile	0.68
End Levee Mile	0.68
Location	Crown
Category	Earthen Levee
Item	Encroachments
Irrigation intake pipe runs through the base of the levee. Stand pipes on waterside and landside. A butterfly valve is located near waterside slope.	
mkhashch_f_20130923_560.JPG

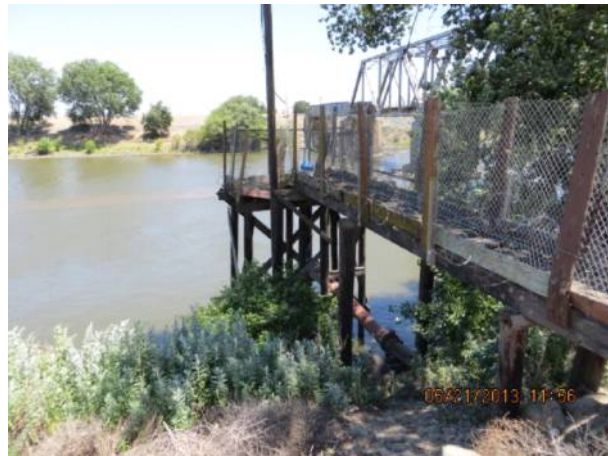
Levee Mile Report Line	20
Start Levee Mile	0.68
End Levee Mile	0.68
Location	Crown
Category	Supplemental
Item	DWR UCIP Field Study
Walkway to pump on pier at WS.	
UCIP_7409.jpg

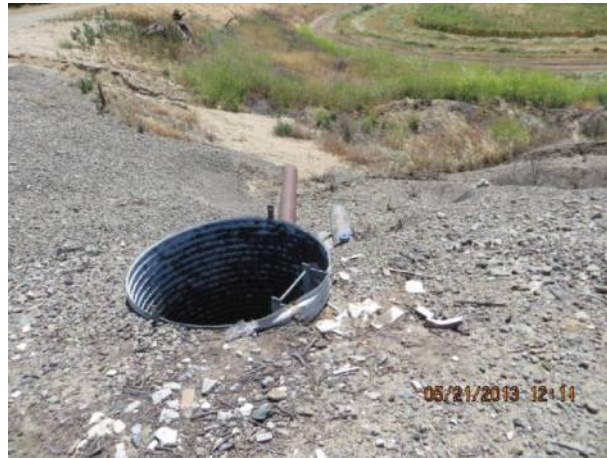
LMR No.	Levee Mile		Category	Item	Location	Rating	Action/Comment	GPS Latitude/Longitude		Issue No.
	Start	End						Start	End	Photo
21	0.70	0.70	Supplemental	DWR UCIP Field Study	LS	M En	Inspector Comments: FS_ID:13883 EP_NO: N/A Repair Type: Non-Urgent Crossing Status: Found UCIP Comments: Slide gate missing actuator inside 55-inch CMP riser. FIELD_STRUCT_DESC: 14-inch pipe through the levee, 15.0 feet below the crown. Pipe likely runs from 36-inch concrete standpipe on LS to outlet on WS toe. Portion of the discharge line from the pump at Levee Mile 0.68. 55-inch CMP riser with slide gate on LS shoulder. Originally included in O&M manual, 1964. FS Date: 5/21/2013	37.779209 ° -121.301973 °	37.779209 ° -121.301973 °	69 Y
DWR ID: DWR_RD2107_01_f_2013_69										
22	0.70	0.70	Supplemental	DWR UCIP Field Study	LS	M En	Inspector Comments: FS_ID:13678 EP_NO: N/A Repair Type: Non-Urgent Crossing Status: Found UCIP Comments: Slide gate missing actuator inside 55-inch CMP riser. FIELD_STRUCT_DESC: 14-inch pipe through the levee, 15.0 feet below the crown. Pipe likely runs from 36-inch concrete standpipe on LS to outlet on WS toe. Portion of the discharge line from the pump at Levee Mile 0.68. 55-inch CMP riser with slide gate on LS shoulder. Originally included in O&M manual, 1964. FS Date: 5/21/2013	37.779209 ° -121.301973 °	37.779209 ° -121.301973 °	70 Y

Levee Mile Report Line	21
Start Levee Mile	0.70
End Levee Mile	0.70
Location	Land Side
Category	Supplemental
Item	DWR UCIP Field Study
55-inch CMP riser with slide gate (no handle) on LS shoulder. 14-inch and 12-inch pipe visible on LS toe.	
UCIP_7476.jpg

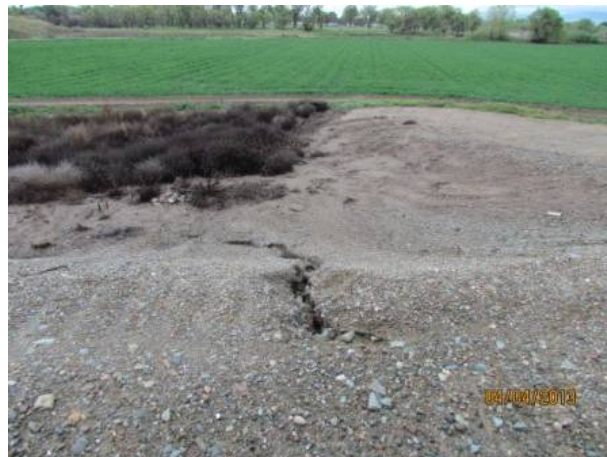
DWR ID: DWR_RD2107_01_f_2013_70										
23	0.76	0.76	Earthen Levee	Erosion / Bank Caving	WS	M Ma	E1 : Note and monitor erosion site.	37.778819 ° -121.302848 °	37.778819 ° -121.302848 °	10 Y
DWR ID: DWR_RD2107_01_s_2013_10										
24	1.24	1.24	Earthen Levee	Vegetation	LS	M En	V6 : Landscaping Inspector Comments: Landscaping and fence present on levee slope.	37.774123 ° -121.307189 °	37.774123 ° -121.307189 °	17 Y
DWR ID: DWR_RD2107_01_s_2012_17										
25	1.46	1.46	Supplemental	DWR UCIP Field Study	LS	M En	Inspector Comments: FS_ID:13667 EP_NO: 12790 Repair Type: Non-Urgent Crossing Status: Indicator Found UCIP Comments: Verify with electricity provider that electric service is overhead and not through the levee. FIELD_STRUCT_DESC: 1 of 3: Possible underground electrical conduit through the levee at unknown depth. Overhead power line on site likely installed instead of underground. (Permit No. 12790, 1981). FS Date: 5/21/2013	37.771939 ° -121.305063 °	37.771939 ° -121.305063 °	71 Y

Levee Mile Report Line	23
Start Levee Mile	0.76
End Levee Mile	0.76
Location	Water Side
Category	Earthen Levee
Item	Erosion / Bank Caving
View of the eroding waterside levee slope.	
mkhashch_f_20130923_562.JPG

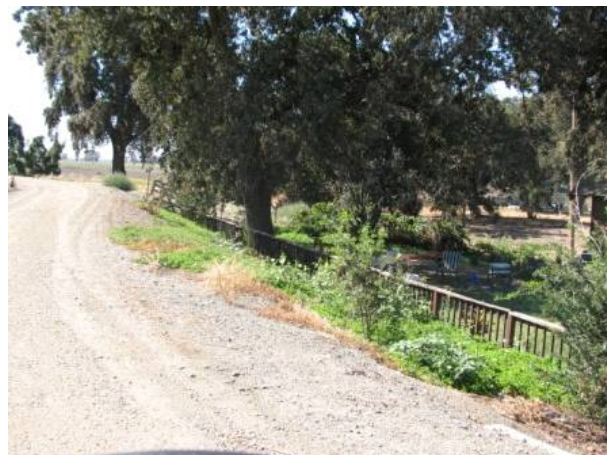
Levee Mile Report Line	24
Start Levee Mile	1.24
End Levee Mile	1.24
Location	Land Side
Category	Earthen Levee
Item	Vegetation
Fall 2009 photo of landscape planting on landside levee slope and a 3-ft yard fence at the levee toe.	
mkhashch_f_20130923_564.jpg

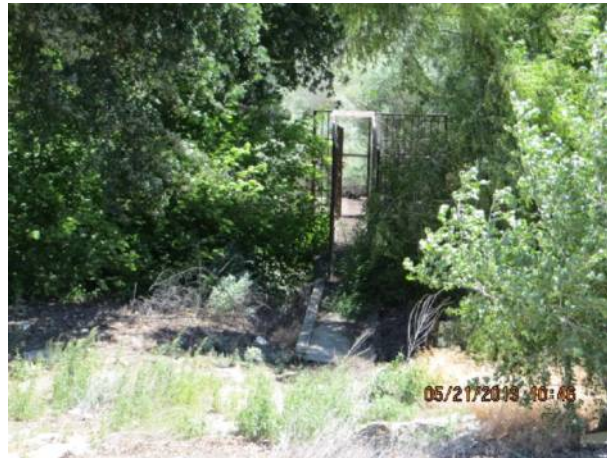
Levee Mile Report Line	27
Start Levee Mile	1.48
End Levee Mile	1.48
Location	Crown
Category	Supplemental
Item	DWR UCIP Field Study

Metal pier on WS slope.

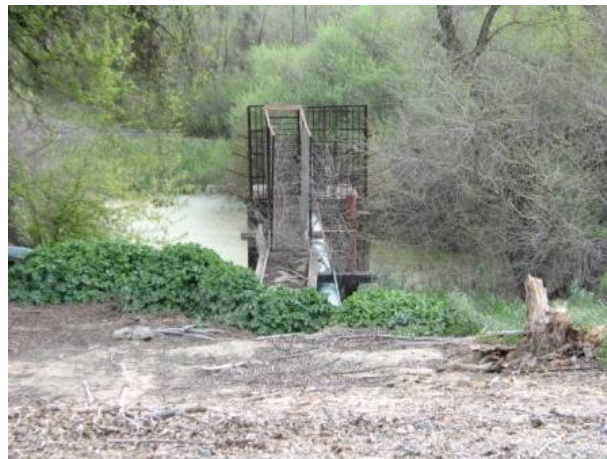
Levee Mile Report Line	28
Start Levee Mile	1.49
End Levee Mile	1.49
Location	Crown
Category	Earthen Levee
Item	Encroachments

DWR ID: DWR_RD2107_01_f_2013_73										
28	1.49	1.49	Earthen Levee	Encroachments	CR A/W	Ma	PI : Pipe Inspector Comments: Irrigation intake pump. Unable to locate closure valve/gate.	37.771636 ° -121.304773 °	37.771636 ° -121.304773 °	9 Y
DWR ID: DWR_RD2107_01_s_2012_9										
29	2.21	2.21	Earthen Levee	Encroachments	CR A/W	Ma	PI : Pipe Inspector Comments: Irrigation intake pipe through levee freeboard.	37.762868 ° -121.309708 °	37.762868 ° -121.309708 °	11 Y
DWR ID: DWR_RD2107_01_s_2012_11

Irrigation intake pipe through levee freeboard.

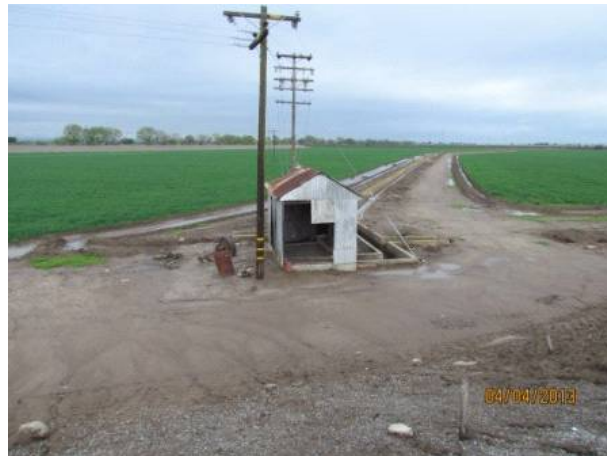
Levee Mile Report Line	29
Start Levee Mile	2.21
End Levee Mile	2.21
Location	Crown
Category	Earthen Levee
Item	Encroachments

View of the pipe location; alignment through levee.

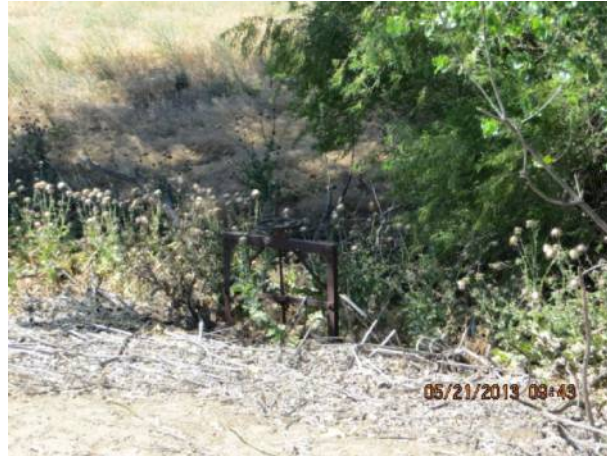
Levee Mile Report Line	1
Start Levee Mile	0.26
End Levee Mile	0.26
Location	Crown
Category	Supplemental
Item	DWR UCIP Field Study

Slide gate visible on WS toe.

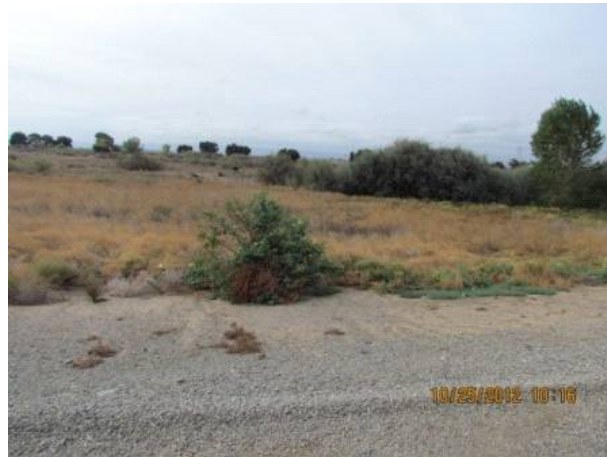
Levee Mile Report Line	2
Start Levee Mile	0.50
End Levee Mile	0.50
Location	Water Side
Category	Earthen Levee
Item	Vegetation

Elderberry located on waterside slope.

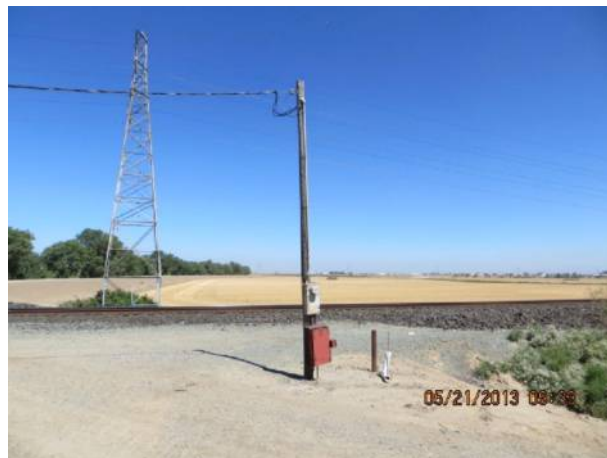
Levee Mile Report Line	3
Start Levee Mile	0.54
End Levee Mile	0.54
Location	Water Side
Category	Supplemental
Item	DWR UCIP Field Study

JP and meter on LS shoulder.

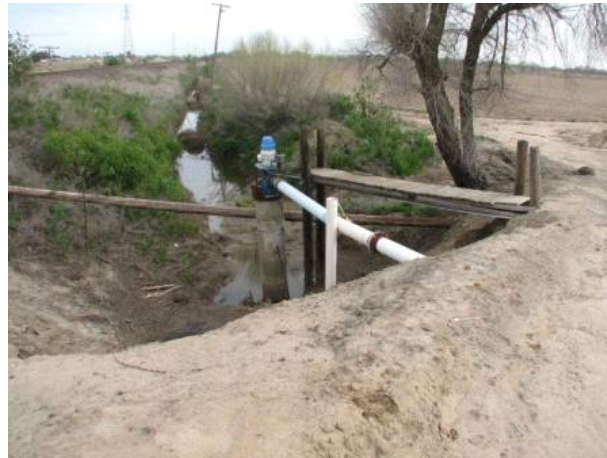
Levee Mile Report Line	4
Start Levee Mile	0.55
End Levee Mile	0.55
Location	Crown
Category	Earthen Levee
Item	Encroachments
Drainage discharge pump. Steel pipe penetrates levee freeboard. No flapgate on waterside. No closure device.	
mkhashch_f_20130923_615.jpg

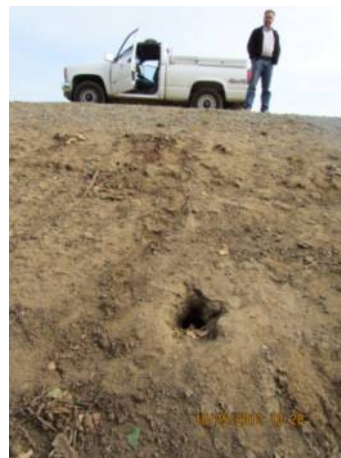
DWR ID: DWR_RD2107_02_s_2012_5										
6	1.05	1.05	Earthen Levee	Animal Control	WS	M Ma	A3 : No rodents visible, but rodent burrows visible; need to backfill and compact or grout burrows. Inspector Comments: Rodent hole does not appear to be active. Recommend backfilling with grout.	37.770171 ° -121.323161 °	37.770171 ° -121.323161 °	6 Y
DWR ID: DWR_RD2107_02_f_2012_6

Levee Mile Report Line	6
Start Levee Mile	1.05
End Levee Mile	1.05
Location	Water Side
Category	Earthen Levee
Item	Animal Control
View of large burrow on waterside slope.	
mkhashch_f_20130923_619.JPG

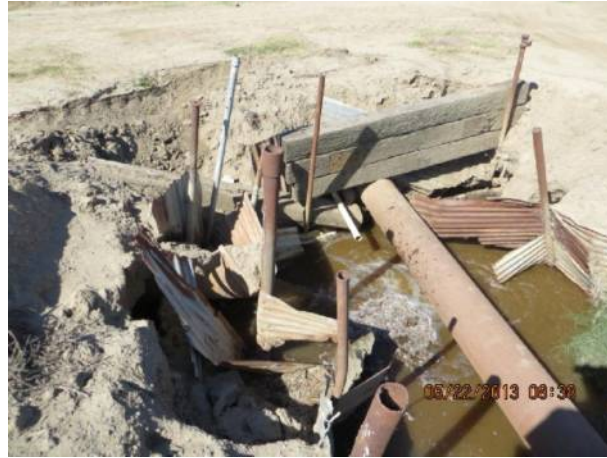
Levee Mile Report Line	7
Start Levee Mile	1.53
End Levee Mile	1.53
Location	Land Side
Category	Supplemental
Item	DWR UCIP Field Study

Headwall failing at drainage ditch on LS toe.

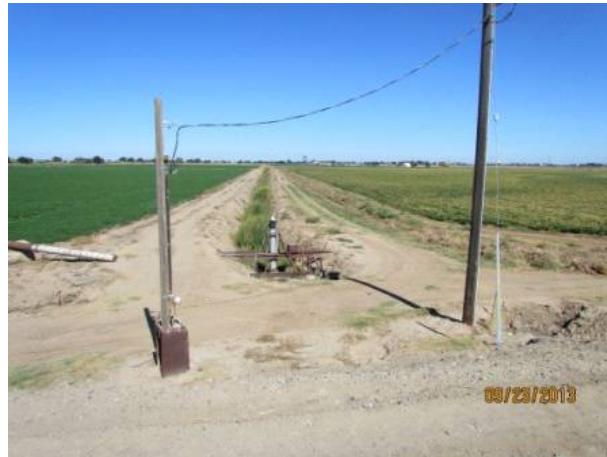
Levee Mile Report Line	8
Start Levee Mile	1.53
End Levee Mile	1.53
Location	Land Side
Category	Earthen Levee
Item	Encroachments

View of irrigation pipe and canal.
